LAKE WICHITA

HOLLIDAY CREEK, WICHITA FALLS, TEXAS LOCAL FLOOD PROTECTION

SPILLWAY FOUNDATION REPORT

U.S. ARMY ENGINEER DISTRICT, TULSA CORPS OF ENGINEERS TULSA, OKLAHOMA

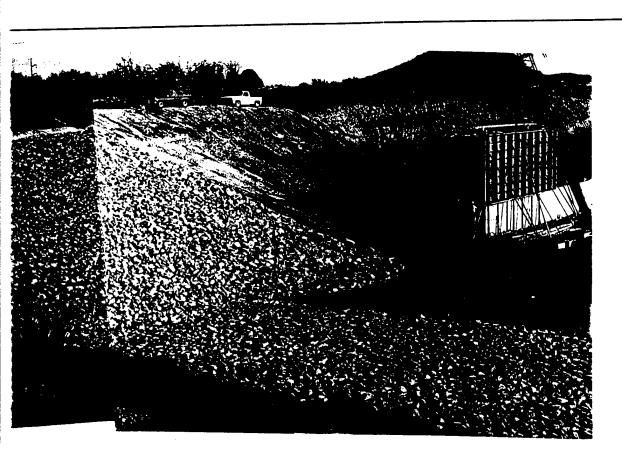
Photo 1. Composite view of the downstream portion of the main spillwa 25 JANUARY 1995

e downstream portion of the main spillway channel.
